CRANKSHAFT REPLACEMENT & ENGINE OVERHAUL AND REBUILD FOR ROYAL SAUDI AIR FORCE POWER STATION

EXTENSIVE REPAIRS EXECUTED ON STORK WERKSPoor 8TM410 GENERATOR

PROJECT FACTS: RSAF TABUK AIR BASE

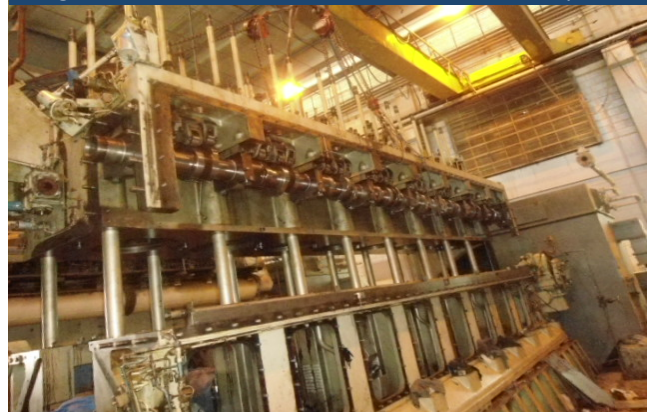
Engine disassembled with block lifted off bedplate

Goltens disassembled the engine components and lifted the block from the bedplate to facilitate removal of the condemned crankshaft. During this process it was discovered that the replacement crankshaft flange holes did not match the existing flanges at the flywheel and vibration damper. As a result, Goltens' performed reaming on both flanges of the new shaft in order to make it suitable for installation.

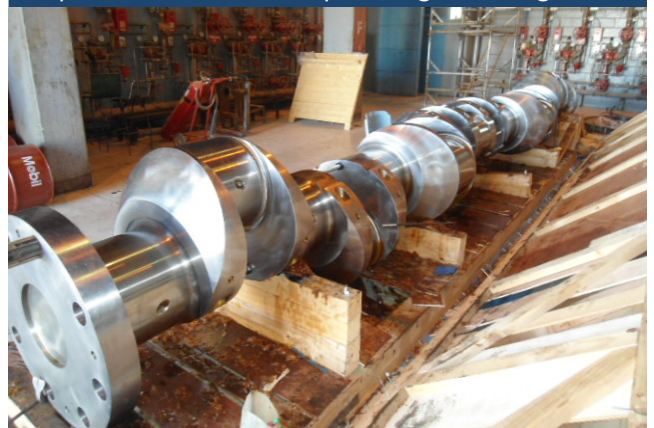
Replacement crankshaft pre-flange reaming

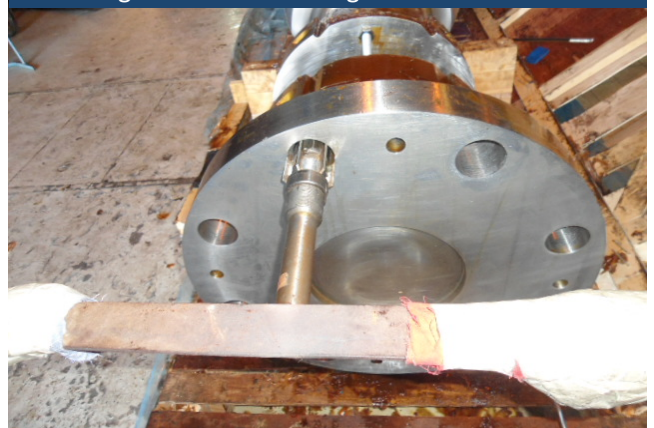
Reaming of crankshaft flange bolts holes

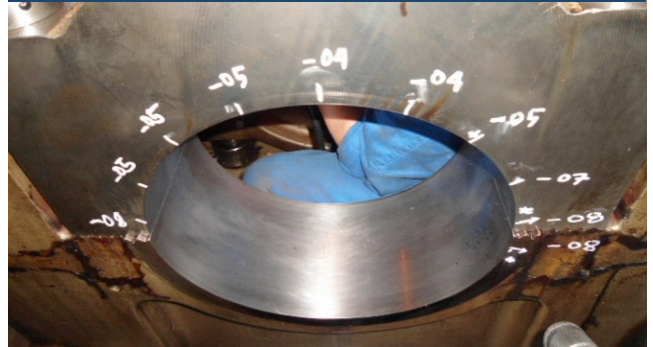
To ensure that the failure had not caused extensive damage to the bedplate a thorough inspection was completed. After the crankshaft was removed, Goltens tightened all of the bearing caps to the required 750 Bar pressure and Goltens' In-Situ machining specialists performed a laser check on the engine alignment and bores. Alignment was found to be acceptable but main bearing bore 3&4 had slight ovality and require minor polishing of the cap to get to the required diameter.

Pocket 3&4 after polishing to correct ovality

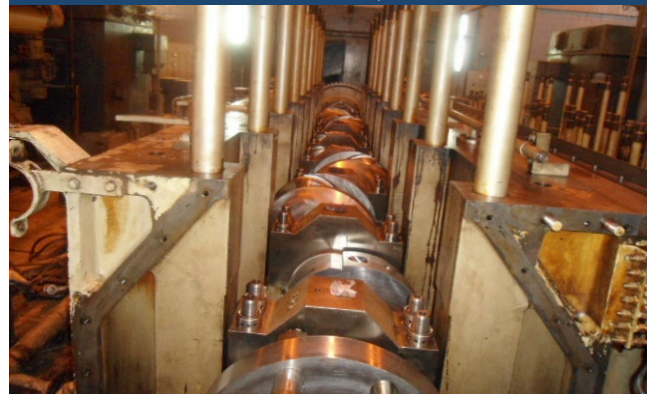
New crankshaft fitted on bedplate
