## LASER ALIGNMENT & IN-SITU MACHINING

### STERN TUBE INNER SEALING SURFACE

#### PROJECT STATS: LEAKING PROPELLER SHAFT SEAL

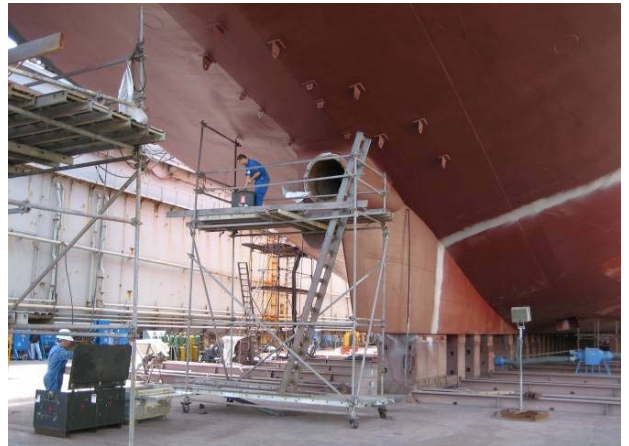
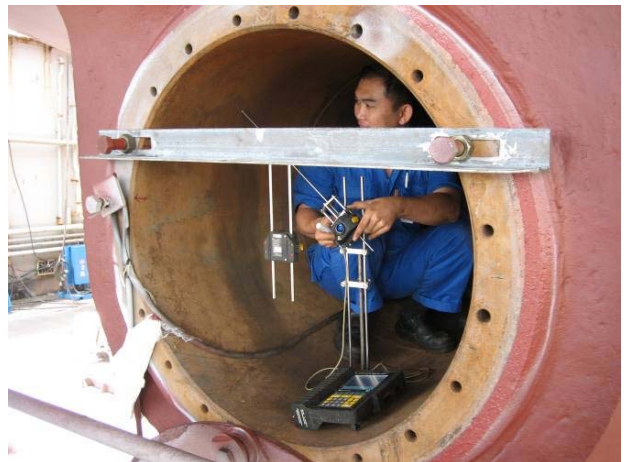
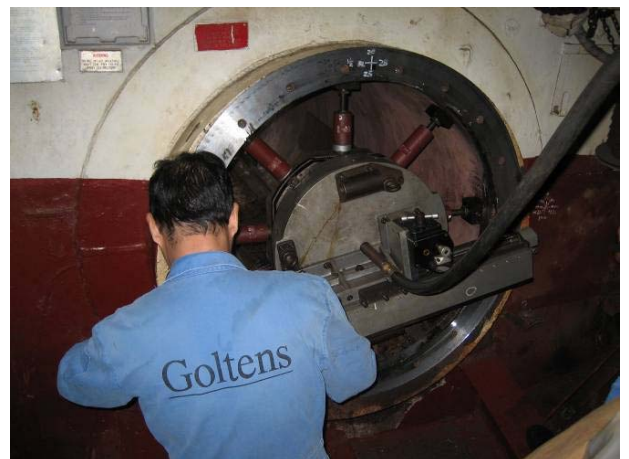
The vessel was inspected, and the point of the leak was identified as the inner sealing surface for the stern tube housing. A proposal was made and approved shortly after.

The inner sealing area was manually welded up, and one of our In-Situ flange facer machines was mounted and aligned against reference points from the laser alignment done earlier. The damaged sealing was machined back to original measurements so the original seals could be used.

- Inspection and isolation of leak
- Laser alignment of propeller shaft line
- Welding of damaged sealing area
- In – Situ machining of sealing flange and inside diameter
