## JOURNAL ANNEALING AND MACHINING

### MAN B&W V9V40/54

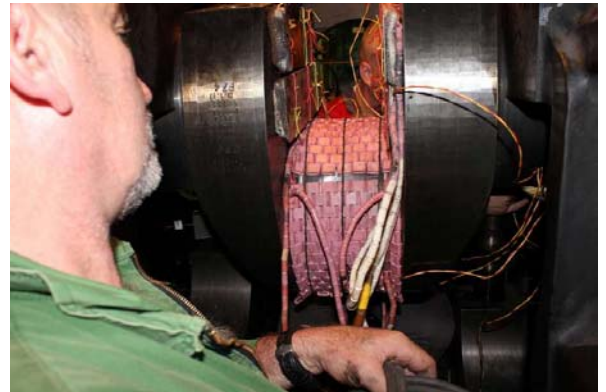
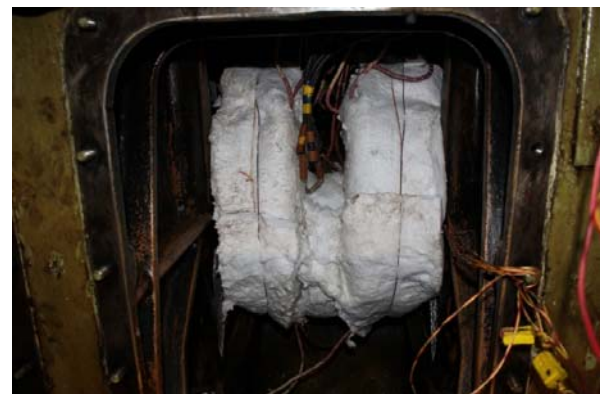
Inspection revealed cracks in the journal surface as well as damaged fillet radii. Goltens in-situ machinists performed local grinding to determine the depth of the cracks and hardness testing to determine whether or not the hardness levels were acceptable.

Hardness testing revealed extreme hardness in BDC of crankpin Nr.5 - hardness measured max. of 630 HB. Based upon the depth of the surface cracks and the hardness Goltens informed the owner that we could remove the hardness with annealing and salvage the shaft at 4-5mm undersize. As the maximum undersize was -5.0mm, without annealing, the crankshaft would be condemned.

Goltens machined new fillet radii and rough machined the journal to remove all surface cracks and completed annealing of the crankpin. Post heat treatment hardness measured between 314 and 320 Brinell.

The crankpin was finish machined to a diameter of 316 mm (-4.0 mm) well within maker limits.
