## BERGEN CRANKSHAFT REPLACEMENT ON AHTS OFFSHORE SUPPLY VESSEL

### MAIN ENGINE: BERGEN B32:40L8P

### PROJECT FACTS: CRANKSHAFT REPLACEMENT

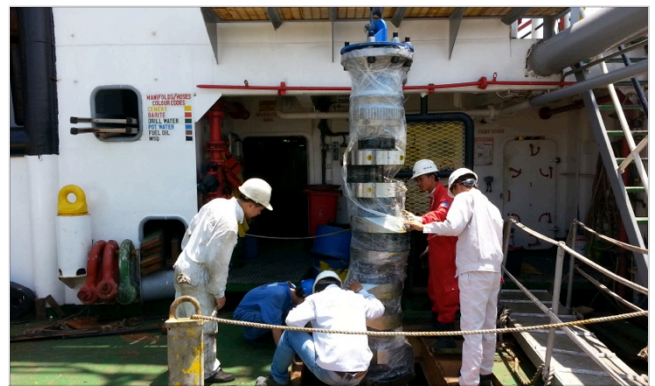
Rigging of replacement crankshaft onboard

All components were packed and prepared for transfer back to the vessel where preparations to rig and install the new crankshaft had already been made. Once rigged into the engine room, Goltens installed the crankshaft and rebuilt the engine with the overhauled components.

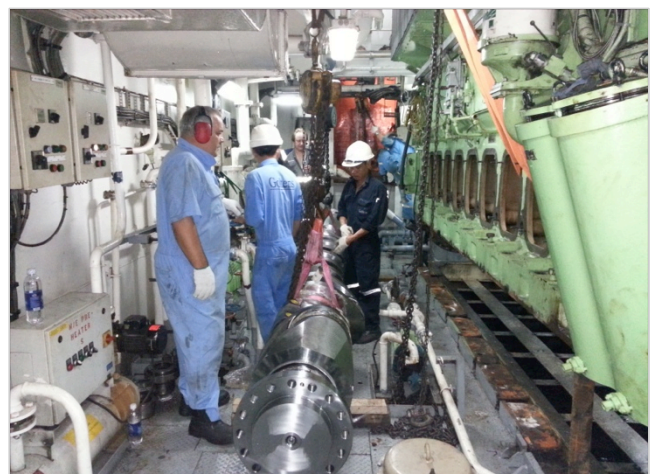
New crankshaft on deck in engine room

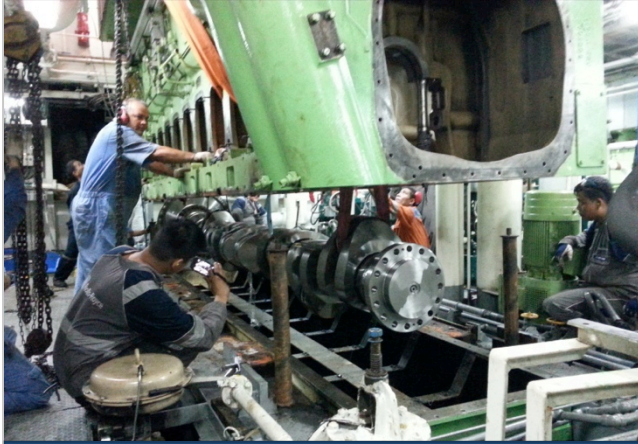
Crankshaft installation in process

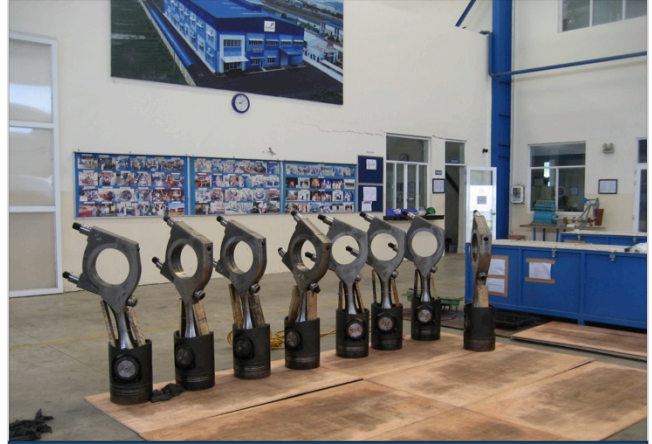
Piston assemblies in workshop for overhaul

In the workshop, Goltens technicians refit the flywheel and damper to the new crankshaft and performed contact tests between the counterweights and the shaft. In addition, Goltens completed calibration checks and overhauled all pistons and connecting rods, replacing the two damaged connecting rods with onboard spare.

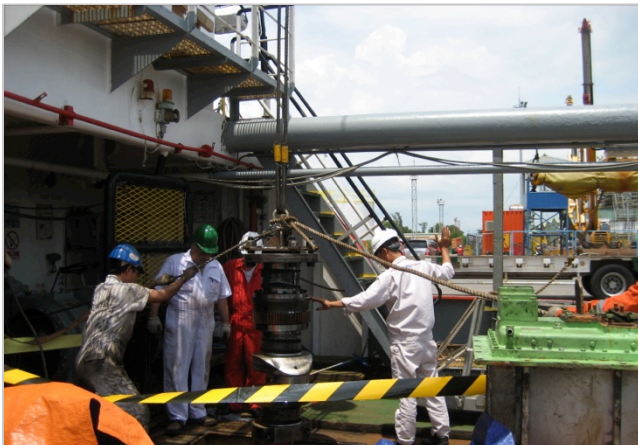
Rigging condemned crankshaft off vessel

Goltens created a work procedure and schedule for the replacement of the crankshaft that was reviewed and approved by the maker and owner. Goltens then manufactured the tools required to lift the engine block and removed the condemned shaft, counterweights, pistons and connecting rods to Goltens workshop.

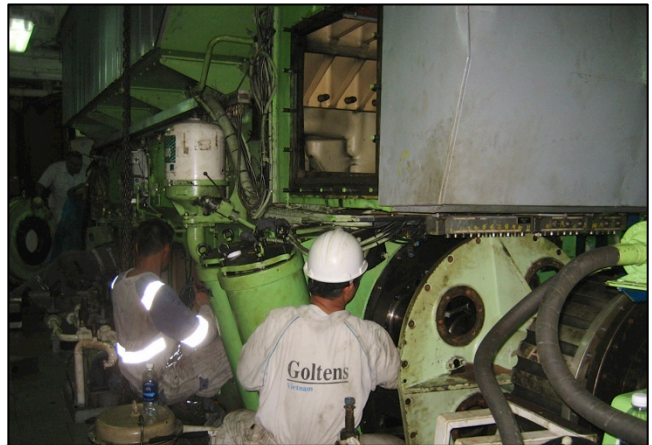
Rebuilding of engine

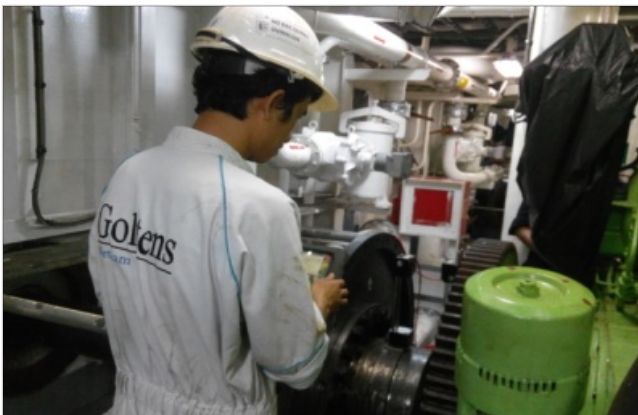
Laser Alignment of engine

Laser alignment was performed on the engine and the team chocked the engine with Chockfast® Orange. Once complete, the engine was flushed and checked by the Rolls Royce engineer and dock and sea trials were completed with no issues. The entire repair was completed in only 20 days and the vessel was returned to service.

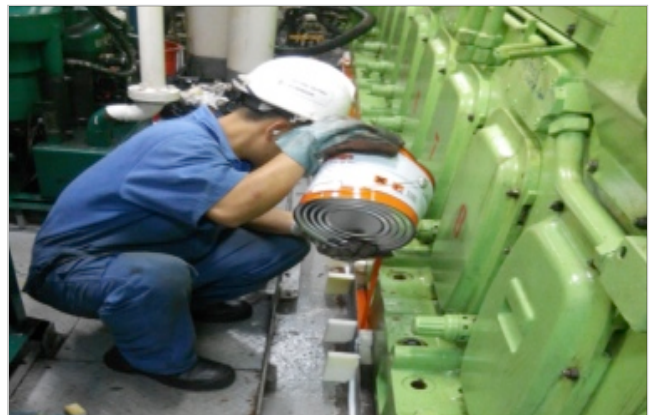
Chocking of engine
