Engineering Excellence: Where Innovation Meets Expertise

Crankshaft replacement in Bahrain
Page 18

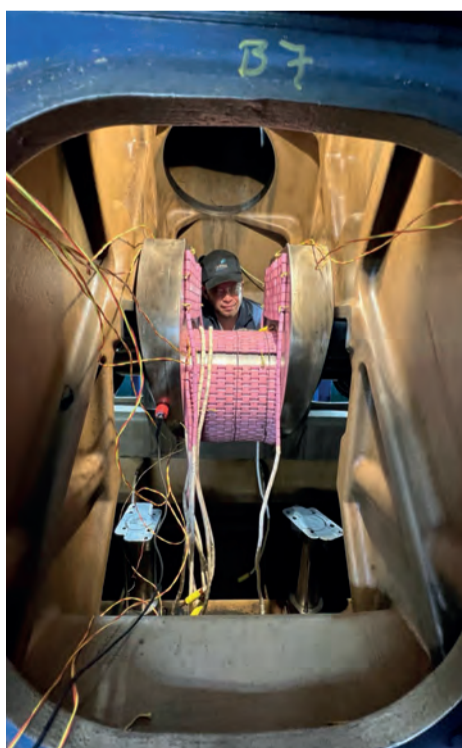
Annealing pads installed on damaged journal

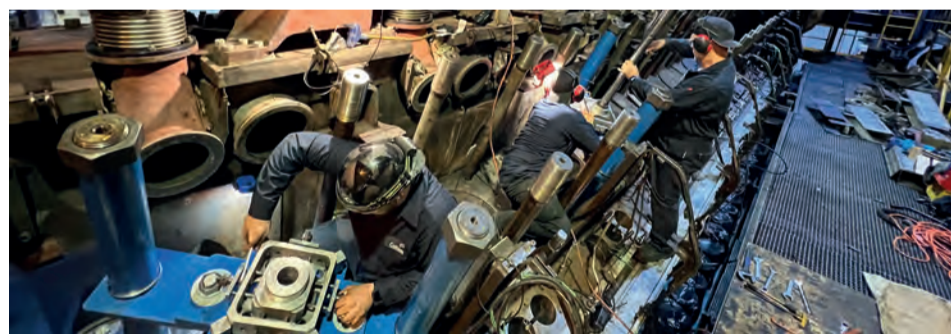
Installation of line boring equipment and dial indicators to check alignment of shaft to block and landing surfaces

Inspection of Crankpins No.2 and No.3 revealed water damage on the surface of the journals, which required machining. Due to a previous crankshaft casualty, Goltens decided to mount line boring equipment in the cylinder liner bores and use dial indicators to ensure there were no legacy alignment issues with the engine. Satisfied that the engine/crankshaft were in alignment,

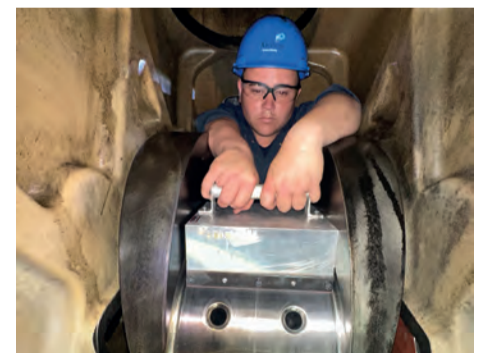
Lapping dummy employed to remove ridge wear found on Engine No.9 to reduce 'point load' risk on rebuild

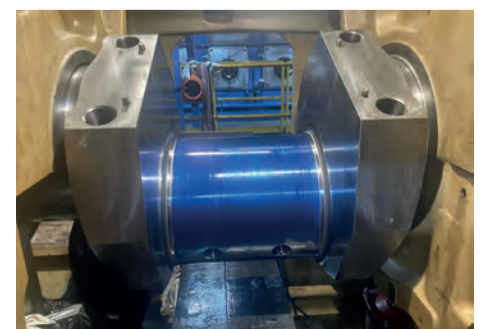
Rectified crankpin showing removal of ridge wear and full surface contact after repair

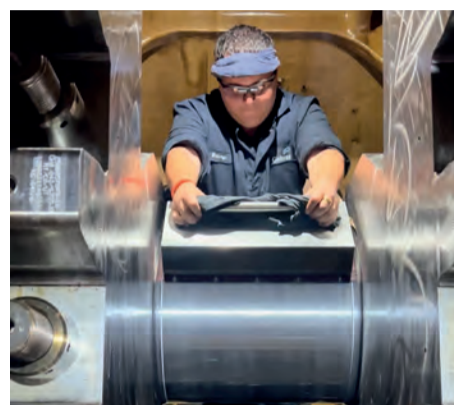
Technician using custom-manufactured mandrel to remove ridge wear

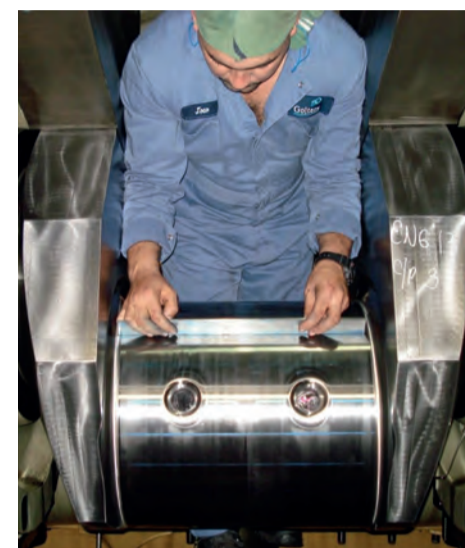
Checking running surface for ridge wear with straight edge

At every major overhaul a crankshaft inspection should be carried out by a qualified professional using a machinist's straight edge and Prussian Blue, as well as a calibrated outside micrometer to evaluate the bearing running surface. If any abnormality in the journal running surface is found, the protrusion should be removed and the crankshaft surface rectified to the maker's recommended tolerances for flatness, taper, ovality, and roughness. This is not a routine undertaking, and the delicate process should be carried out by highly skilled crankshaft specialists from Goltens or the OEM, using a combination of filing, lapping, and bluing. In addition, custom-fabricated mandrels specifically built for the diameter and width of the engine's crankpins should be used.

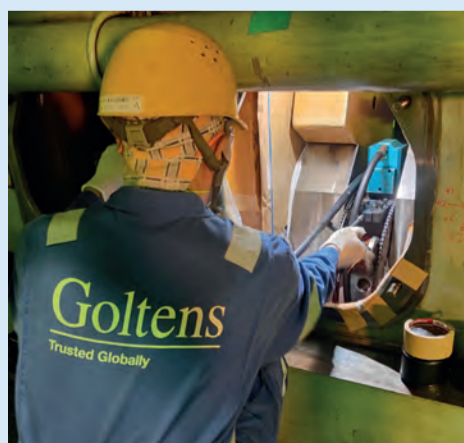
Machining of one of the successfully annealed crankpins

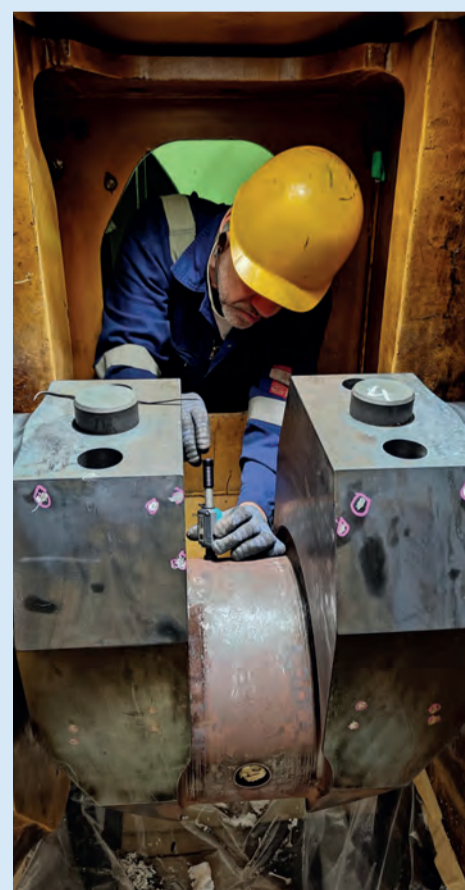
Hardness checks on crankpin journal after annealing and cooling

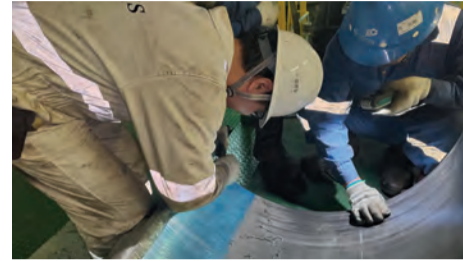
Scraping of intermediate shaft bearing

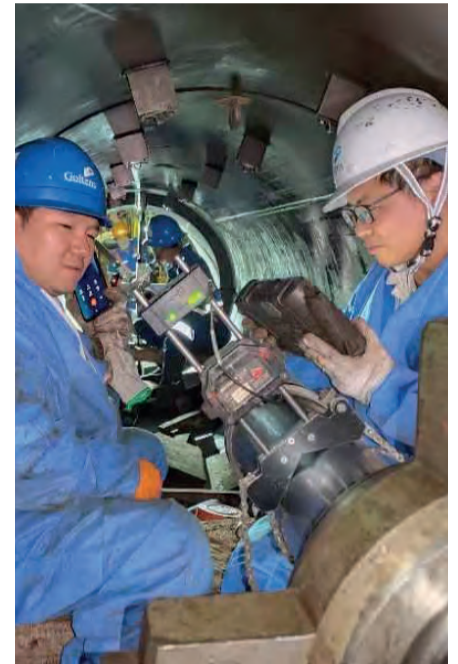
Laser alignment of in-situ boring equipment

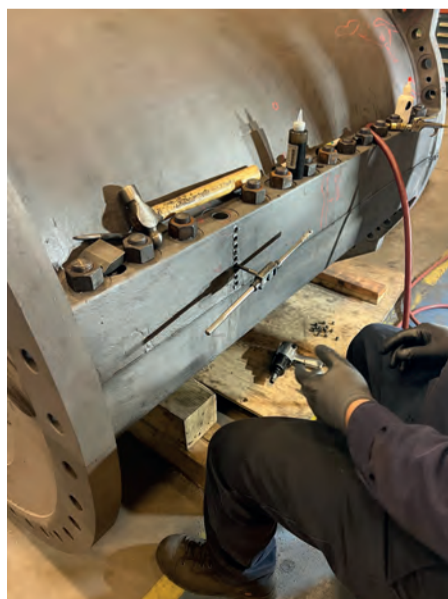
Tapping holes for second set of stitching pins

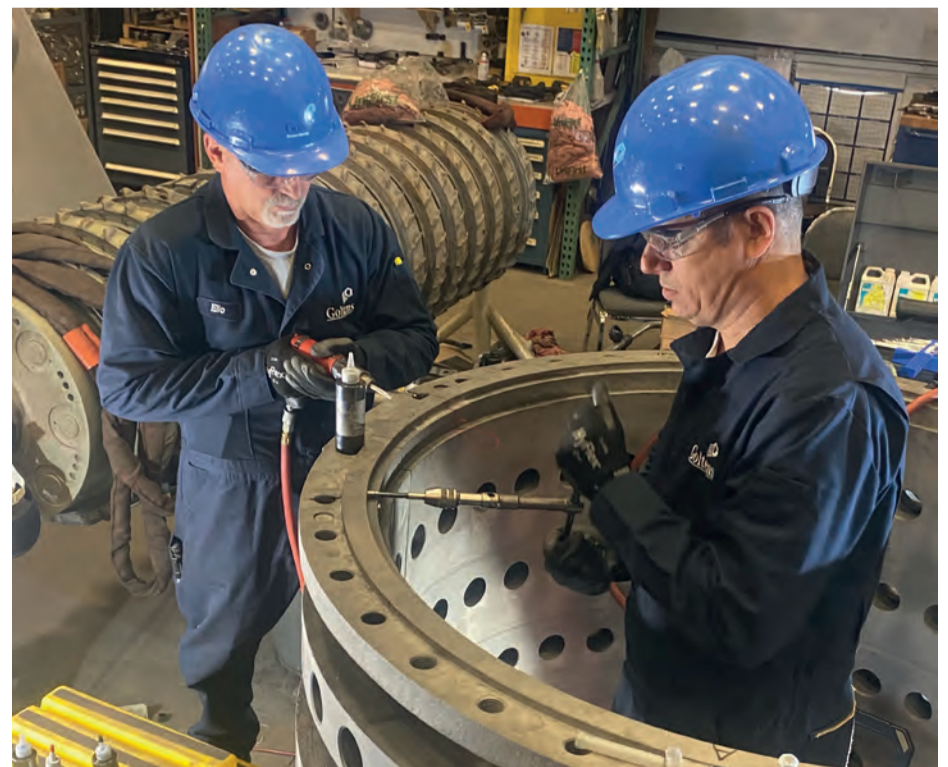
Tapping drilled holes along crack for stitching pins

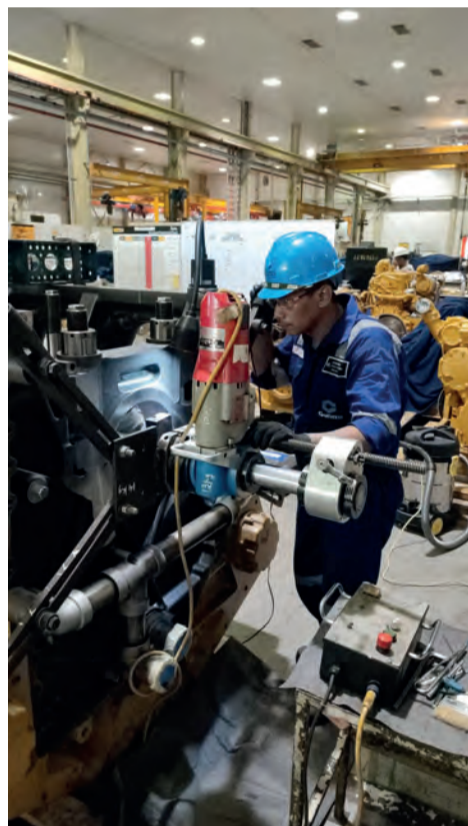
Line boring of CAT 3616

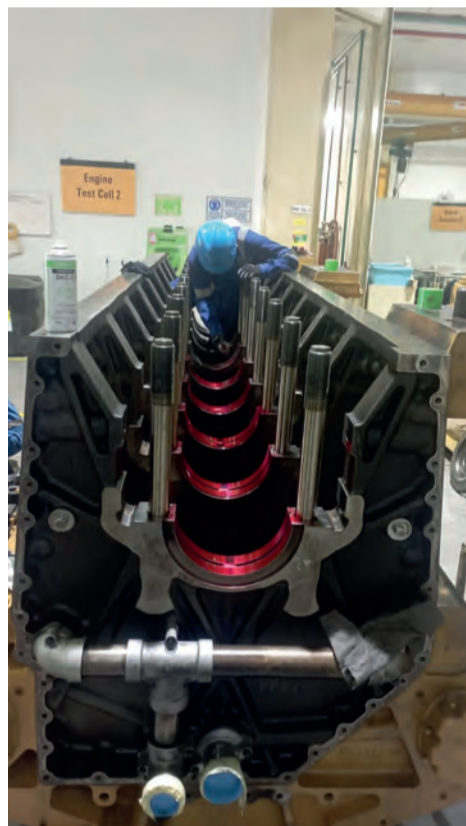
Crack test on bearing pockets

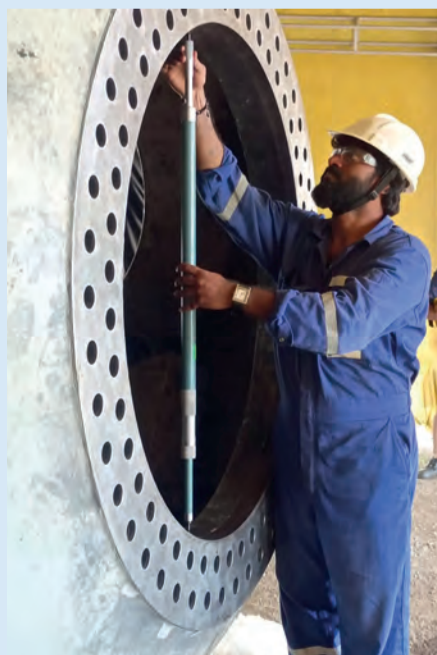
Goltens specialist performing calibration of the WTG hub inner diameter before machining

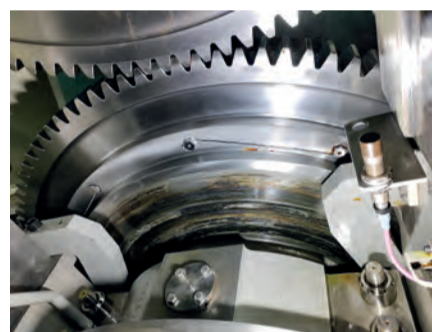
Damage to thrust collar during sea trial before repair

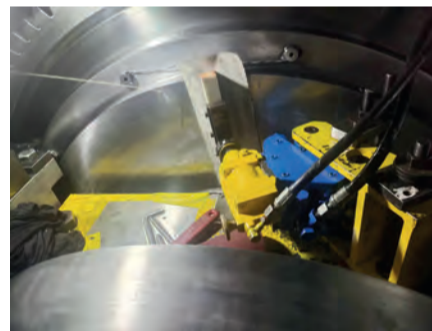
Thrust collar surface honing after machining

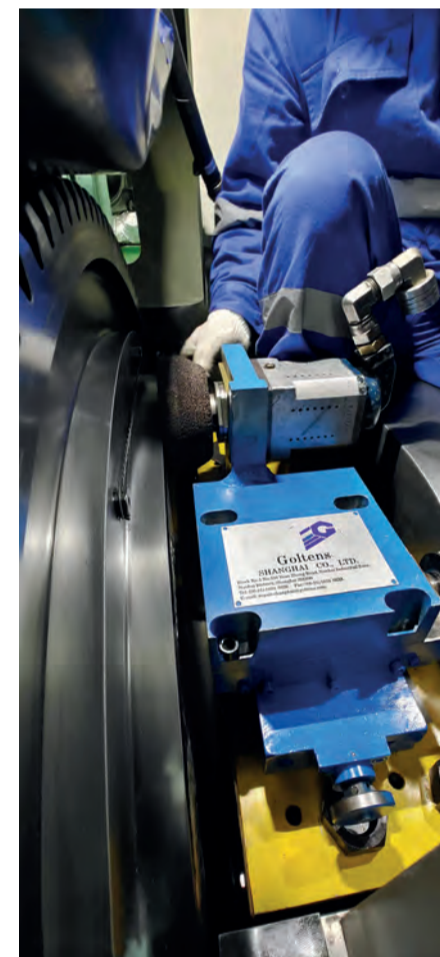
Customized In-Place Machining tools developed by Goltens installed for repair

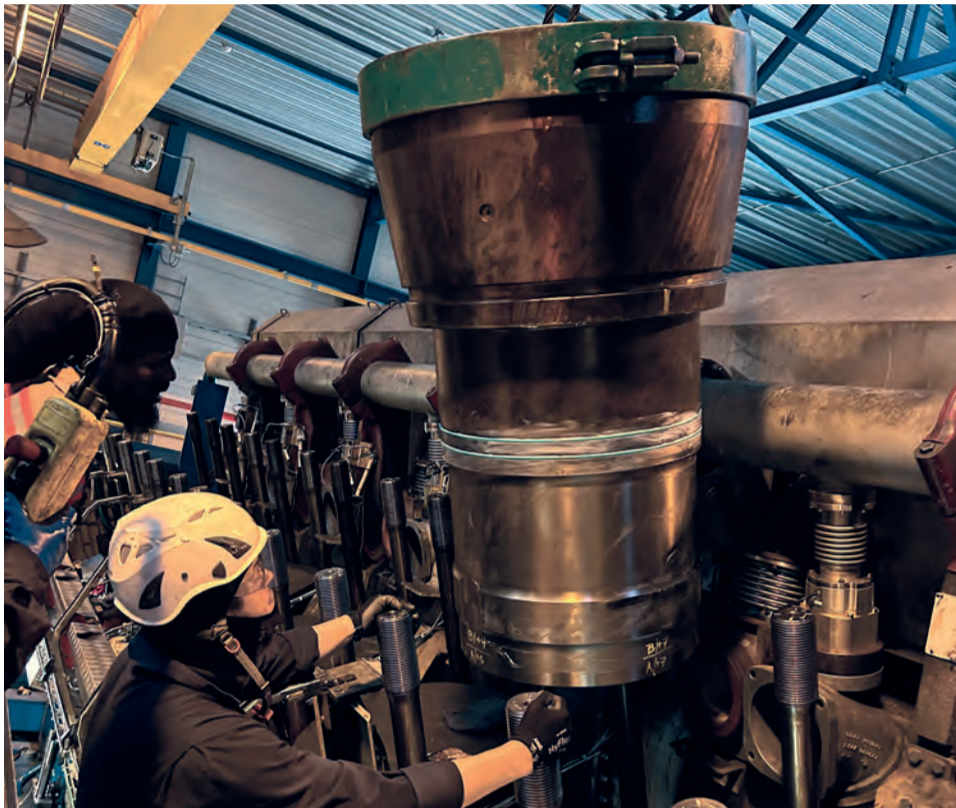
Goltens' technician removing cylinder liner from engine

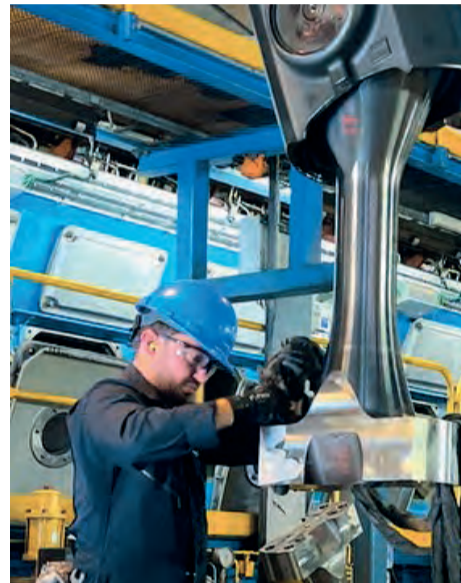
Rigging of one of the piston assemblies to the floor for inspection

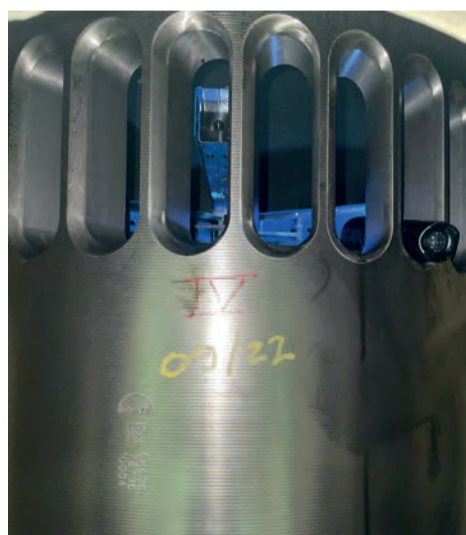
LDM equipment installed on top of the Liner

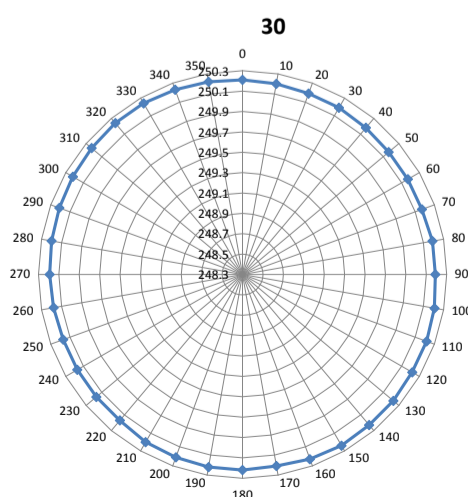
Polar plot of LDM data showing ovality/wear pattern

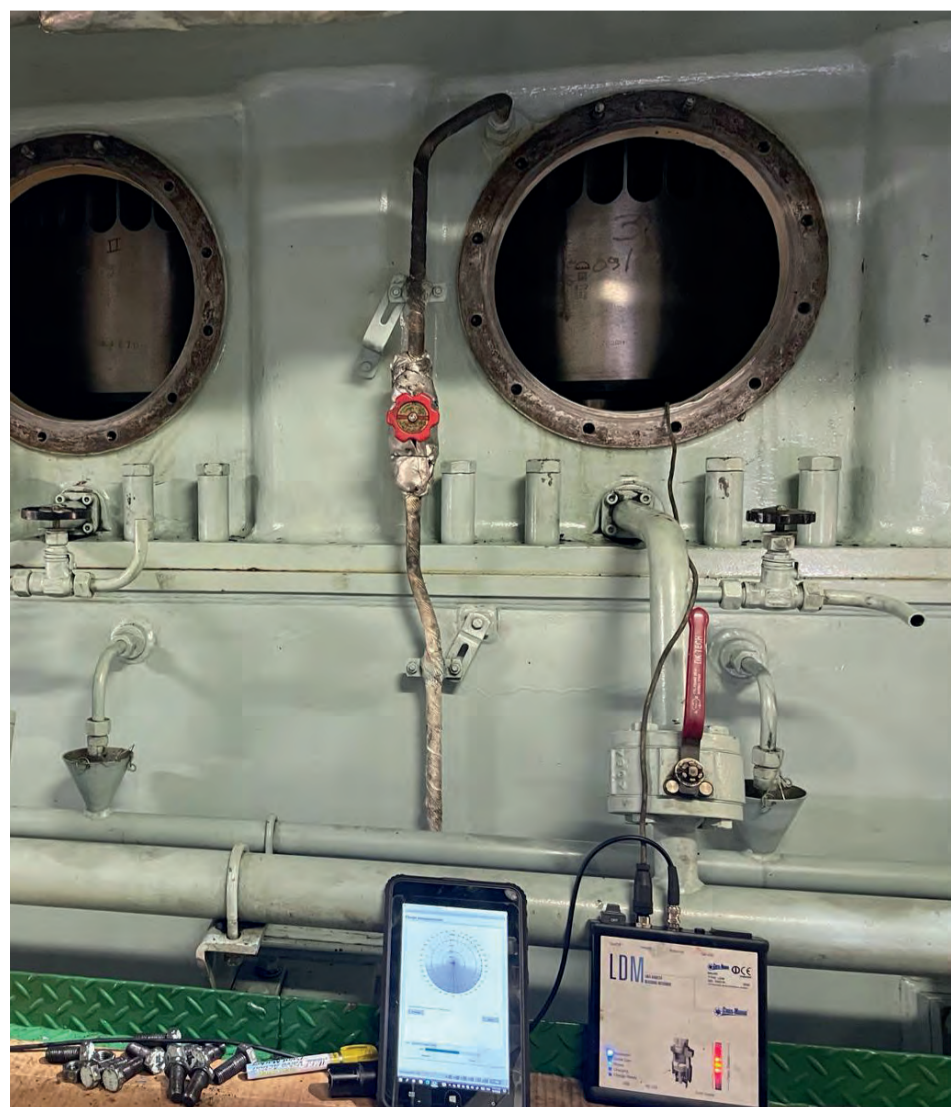
LDM analysis in process on one of the cylinder liners' Alpha lubricators requiring adjustment

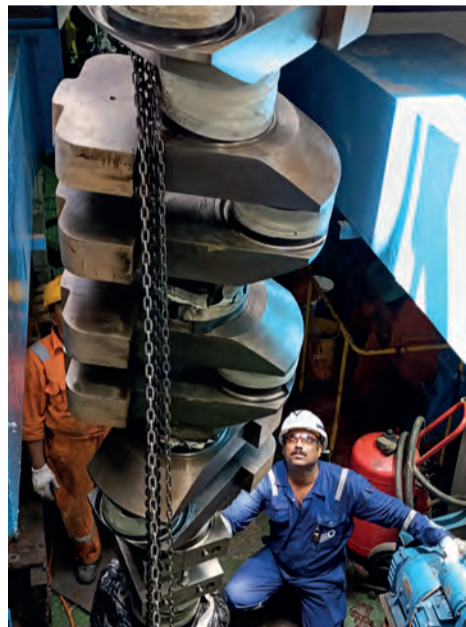
Rigging of damaged crankshaft from below decks for transport to Goltens Dubai

Goltens removed the crankshaft at berth in Bahrain and moved it to Dubai for repair of the damaged crankpin (annealing and machining) and polishing of the others. After annealing, the main journals were machined to undersize as required to straighten the shaft. Goltens then reinstalled the reconditioned crankshaft and performed a full overhaul on the engine prior to returning it to service. ■

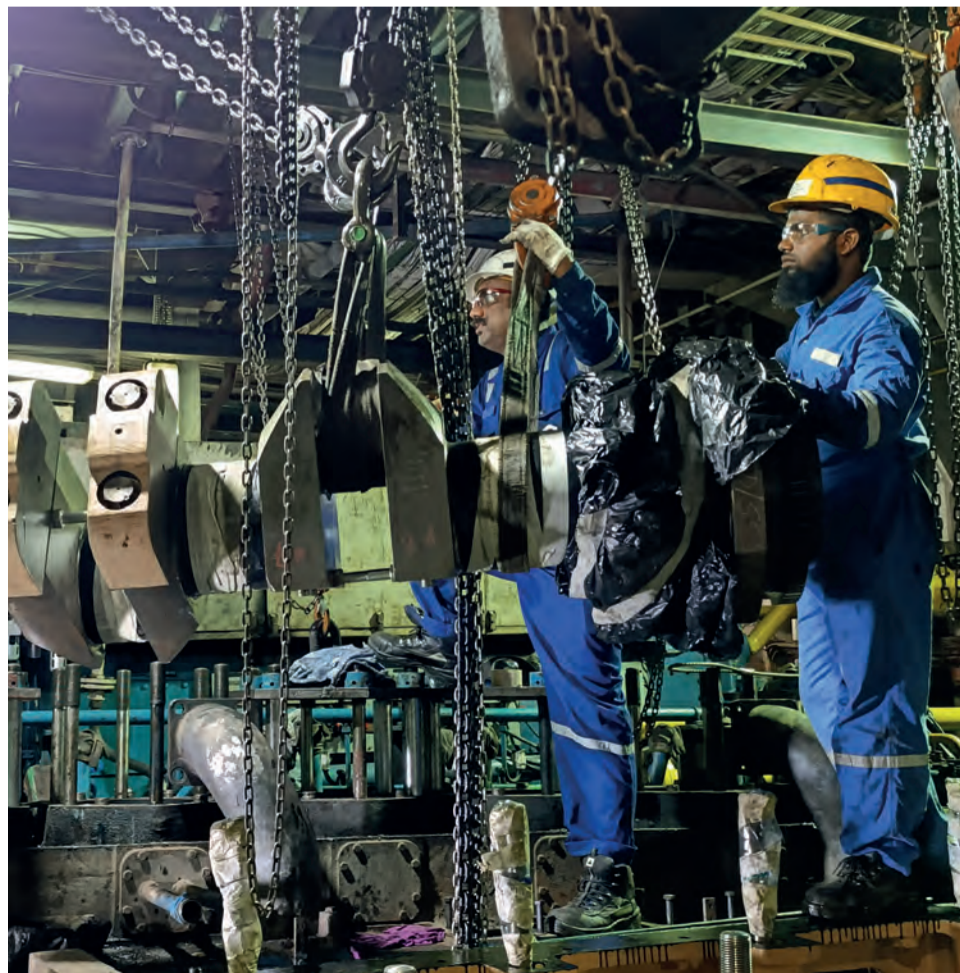
Goltens' specialists rigging crankshaft out of the block in engine room

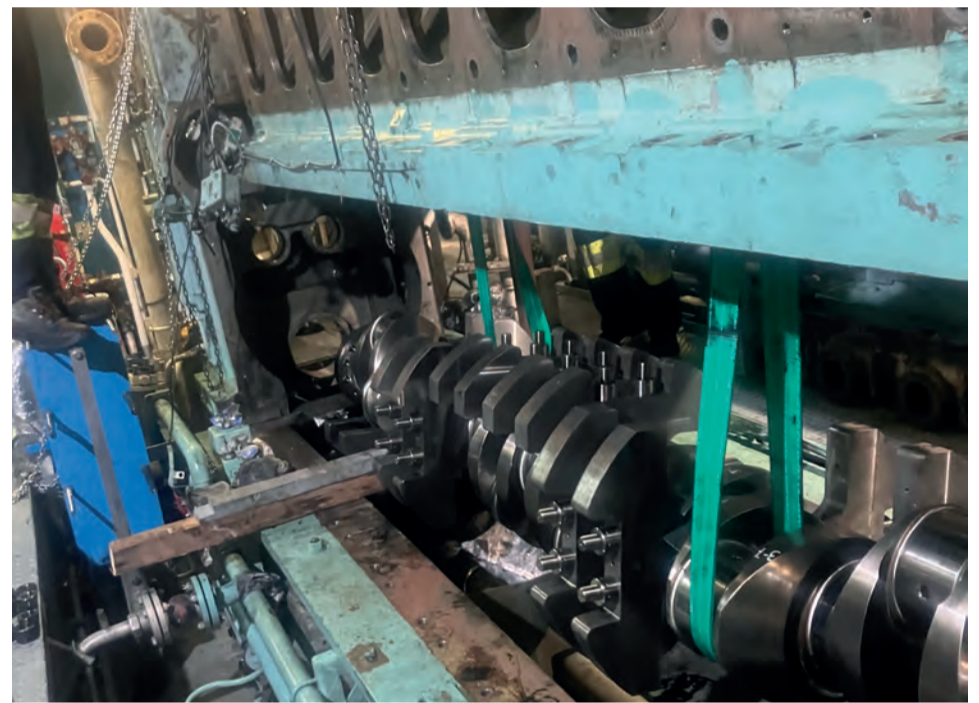
Engine block lifted and condemned crankshaft lowered for removal from engine

Goltens Rotterdam attended an 11-year-old, 4,400-DWT PSV that had experienced a crankshaft failure on one of its four MAN B&W 8L21/31 engines. Our team of specialists inspected the engine and components and completed a full disassembly of the engine, lifting the engine block to remove the crankshaft. All bearing caps and other key components were sent to Goltens Rotterdam for machining and reconditioning. Once removal was complete, the new crankshaft was rigged into the engine room, the engine reassembled with the machined caps and components, successfully aligned and operationally tested. ■

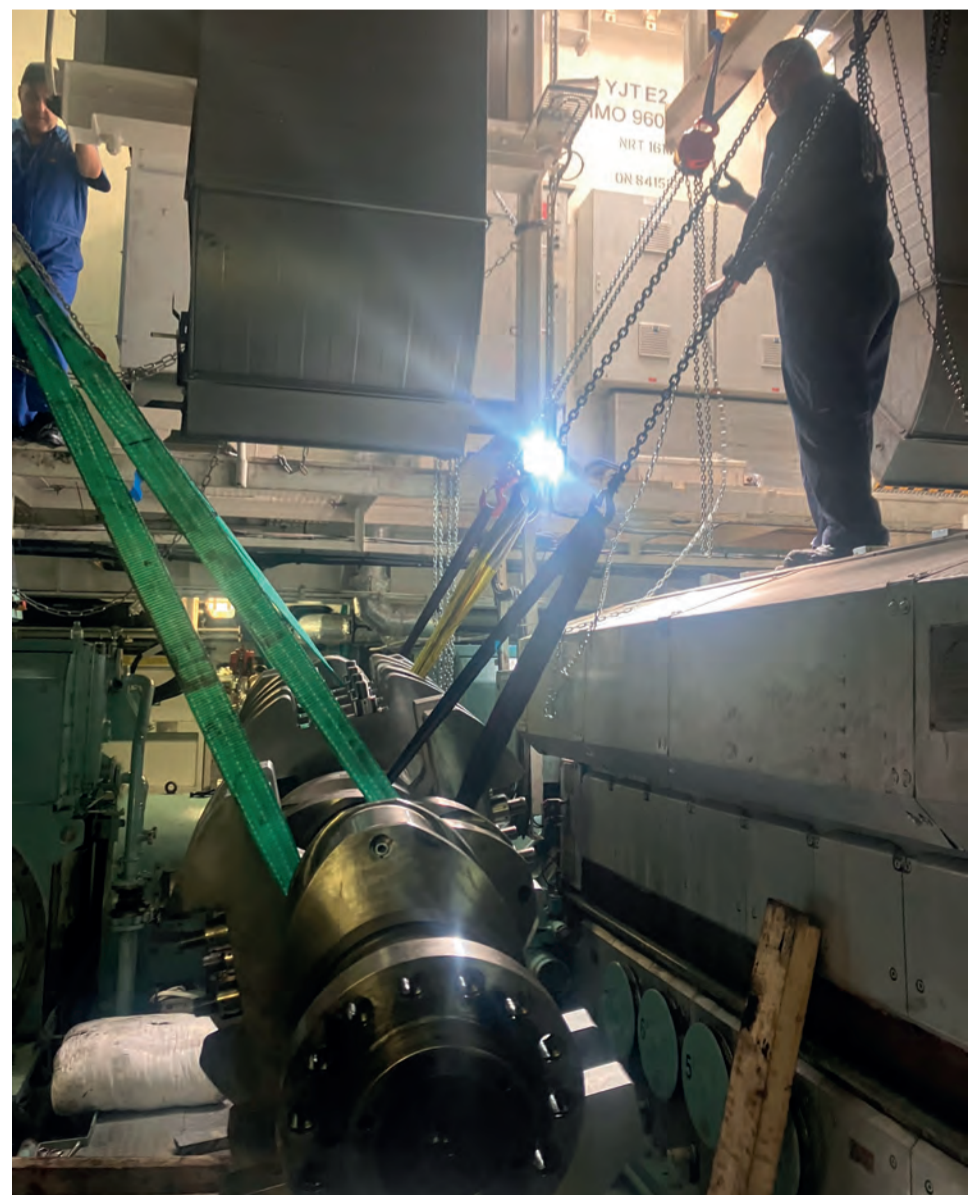
Rigging of the damaged crankshaft from the engine room to the upper deck

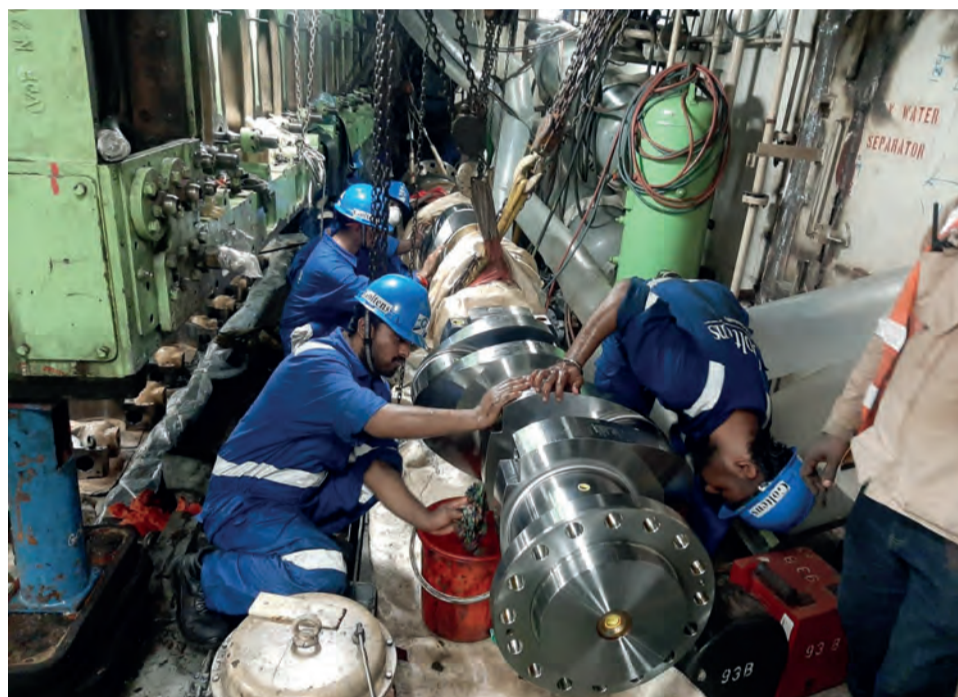
Final cleaning and inspection of new crankshaft prior to assembly

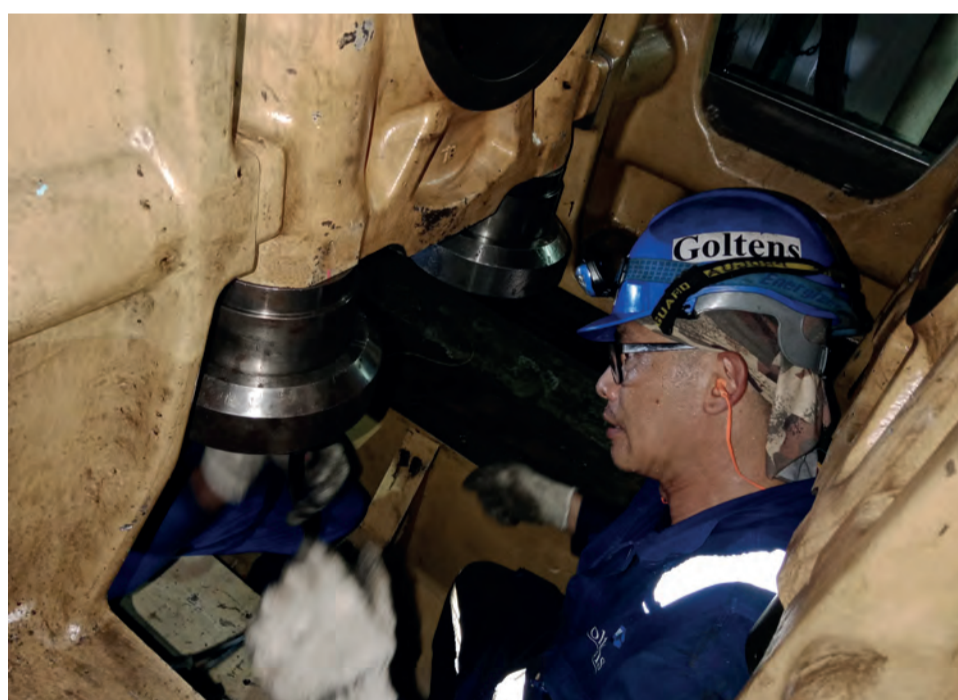
Technician tightening main bearing cap to check the pocket bore alignment

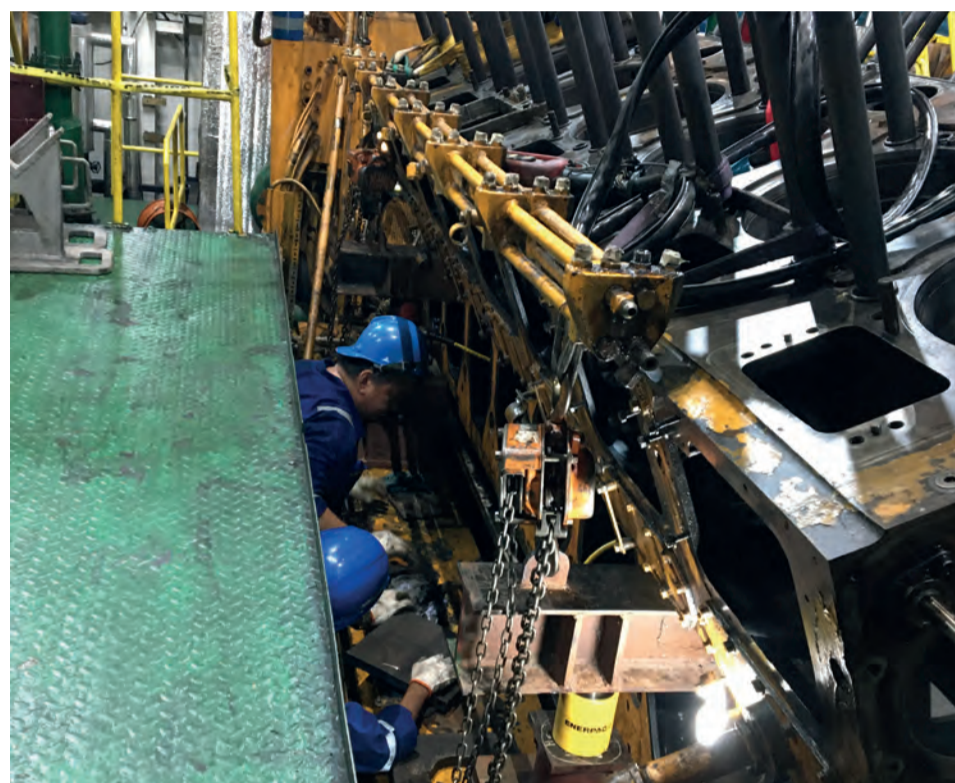
Engine disassembled and engine block jacked and supported for crankshaft

A large operator of multiple, floating power barges in the Philippines experienced an engine seizure on one of its Caterpillar 3616 generators. While the inspection of root cause is still undetermined, the crankshaft was deemed beyond repair and required replacement. Goltens deployed tools and technical specialists to the power barge and completed the removal of the crankshaft. Installation of the replacement crankshaft remains pending receipt of parts and plant decision. ■

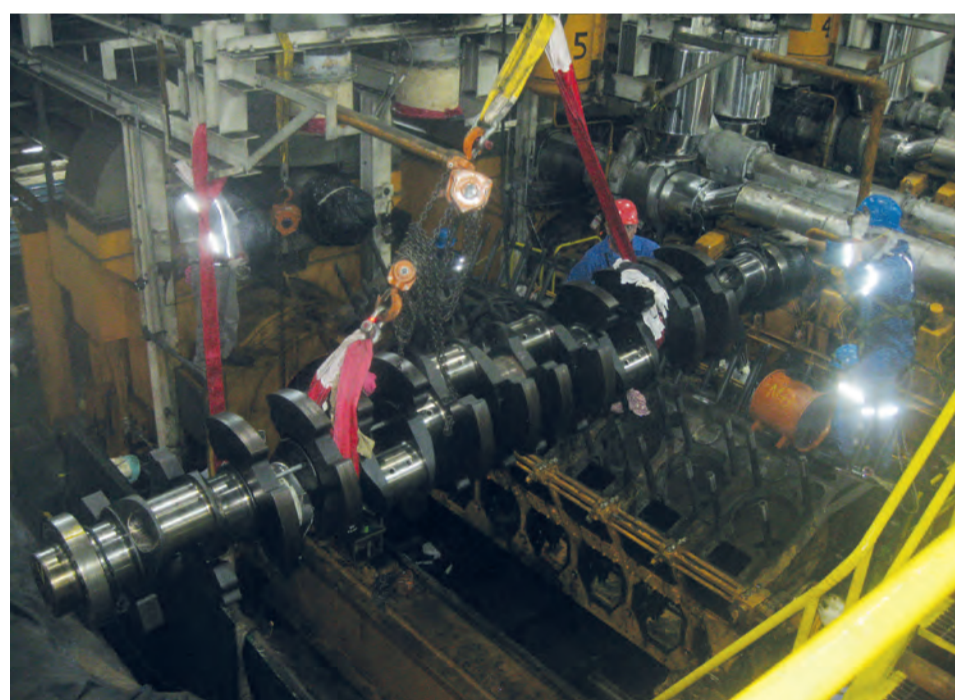
Rigging of the damaged crankshaft from the engine

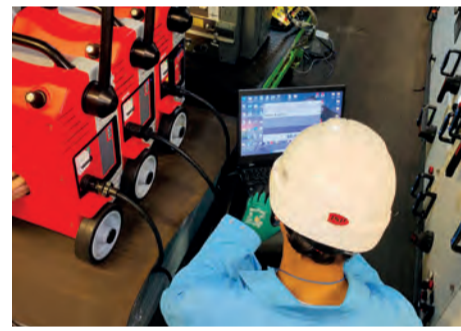
Primary current injection test

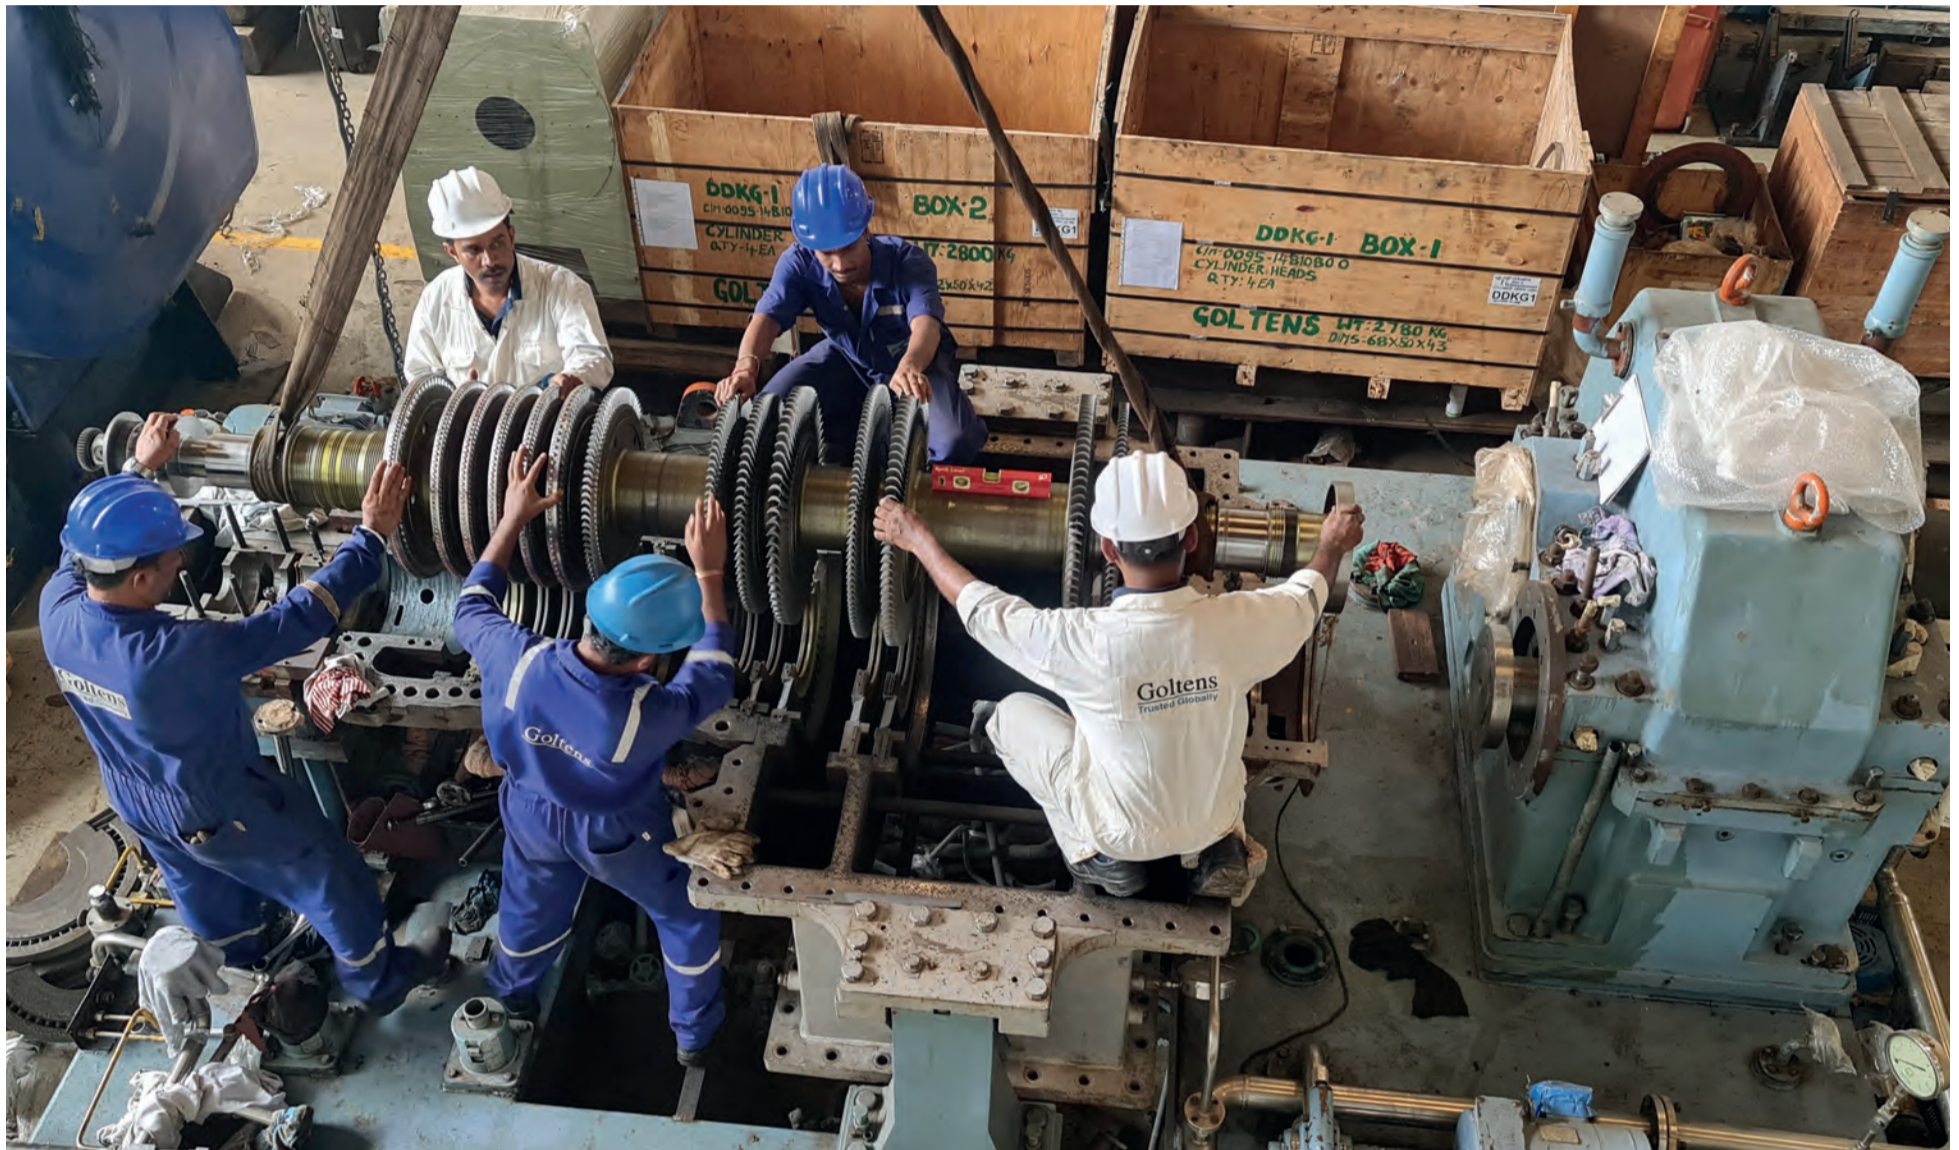
Performance of clearance checks on rotor placement
